Quest Engineering & Failure Analysis, Inc. www.quest-engineering.com

Re: FR26 Report

File: Bryson Accident

Quest No: 10519

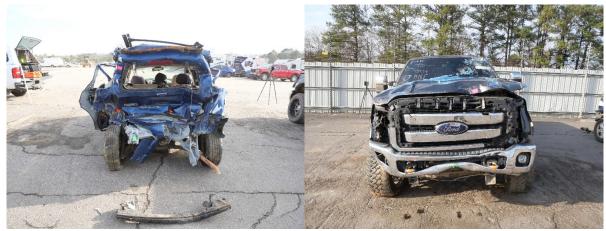
Figure 1: Match points with brightly colored tape

- Impact damage was present on the rear of the Escape demonstrating crush and match points between the F250's:
  - o Bumper to Escape hatch
  - o Tow hooks to Escape hatch

- o Right front tire to Escape's rear
- Impact holes were present near the bottom of the Escape's hatch, about 30 inches apart, from the F250 tow hooks.

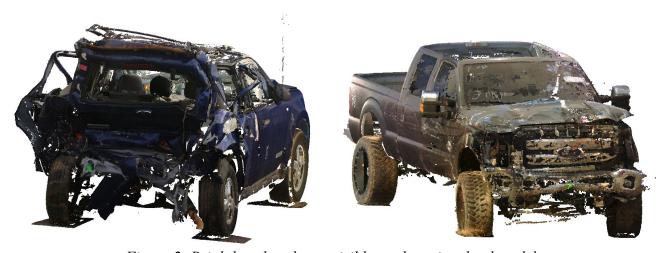
Figure 2: Brightly colored tape visible on the point cloud models

A FARO laser scanner, which collects electronic measurement data about the three-dimensional vehicle, returns a digital 3D point cloud that can be viewed and edited in Computer-Aided Design (CAD) software. In the point cloud of each vehicle, the brightly colored tape that was previously placed on the vehicle at the time of the inspection was readily visible for analysis purposes (*Figure 2*). In addition, the exemplar Safety 1<sup>st</sup> car seat was scanned. The point clouds allowed accurate matching of corresponding vehicle shapes. The scan of the point cloud is useful for several different engineering analysis purposes.
